Manhole Inspection Summary

Manhole # S21GG_024MH

Insp Date: **6/19/07 11:49 AM**

Location Address: **1611 BAKER ST**

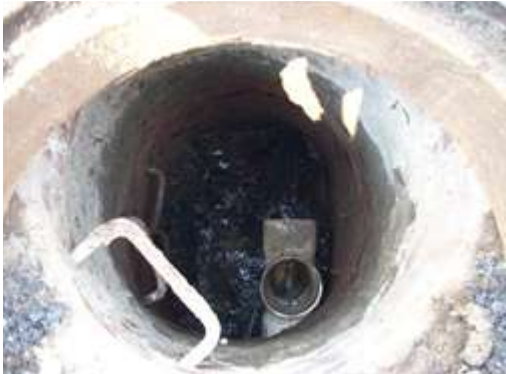
Defect 4

Condition: ☐ Sound ☐ Cracked ☐ Root Intrusion ☐ Deteriorated ☐ Leaks ☒ **Debris**

DEBRIS

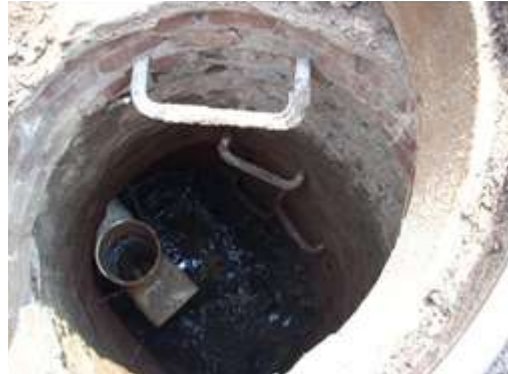
Defect 3

Steps Count: **5** Missing: **0** ☒ **Corroded**

CORRODED STEPS

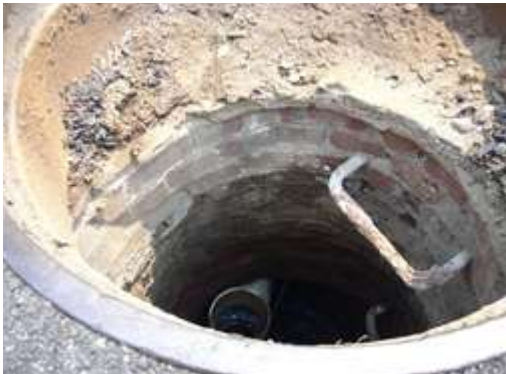
Defect 2

Infiltration: ☐ None ☐ Joint ☐ Cracks ☐ Mortar ☐ Roots ☒ **Wall**

INFILTRATION OF CORBEL

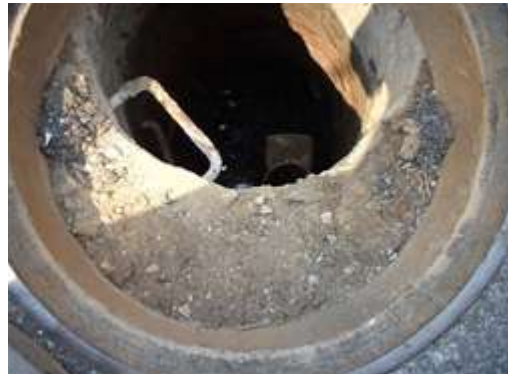
Defect 1

Frame Offset: **12** (in.) Condition: ☒ Sound ☐ Cracked ☐ Leaks

MAJOR FRAME OFFSET 13"

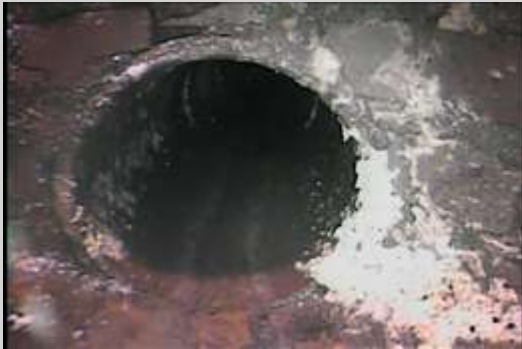
12 O'Clock Outflow

8 in. Circular Gravity Sewer
Pipe Out @ 12 O'Clock

Pipe Height: **8.4** (in.) Rod and Bar (Angled)
Pipe Material: **Clay** ☐ Pipe Lined
Invert Depth: **9.34** (ft.) Flow Characteristics: **Slow**
Deposits: ☒ None ☐ Mud ☐ Sludge ☐ Debris ☐ Grease
Silt Depth: (in.) Deposits Extent:
Infiltration: **None** Pipe Seal Cond: **Sound**

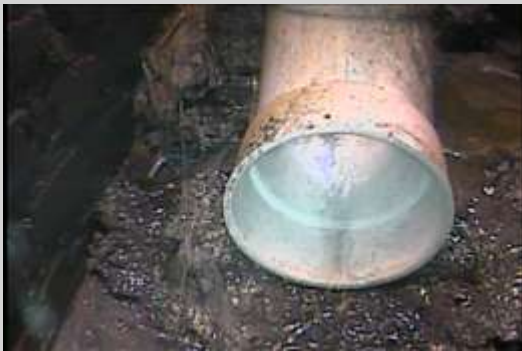
6 O'Clock Inflow

8 in. Circular Gravity Sewer
Pipe In @ 6 O'Clock

Pipe Height: **8.4** (in.) Rod and Bar (Angled)
Pipe Material: **PVC** ☐ Pipe Lined
Invert Depth: **5.71** (ft.) Flow Characteristics: **Slow**
Deposits: ☒ None ☐ Mud ☐ Sludge ☐ Debris ☐ Grease
Silt Depth: (in.) Deposits Extent:
Infiltration: **None** Pipe Seal Cond: **Sound**

Drop: **Outside** Rod and Bar
Angled: **Yes** Reading: **8.11** (ft.)
Inv Depth: **9.11** (ft.)
